Fire Endurance of Open-Web Steel-Joist Floors With Concrete Slabs and Gypsum Ceilings

United States Department of Commerce
National Bureau of Standards
Building Materials and Structures Report 141

James V. Ryan and Edward W. Bender

Issued August 23, 1954

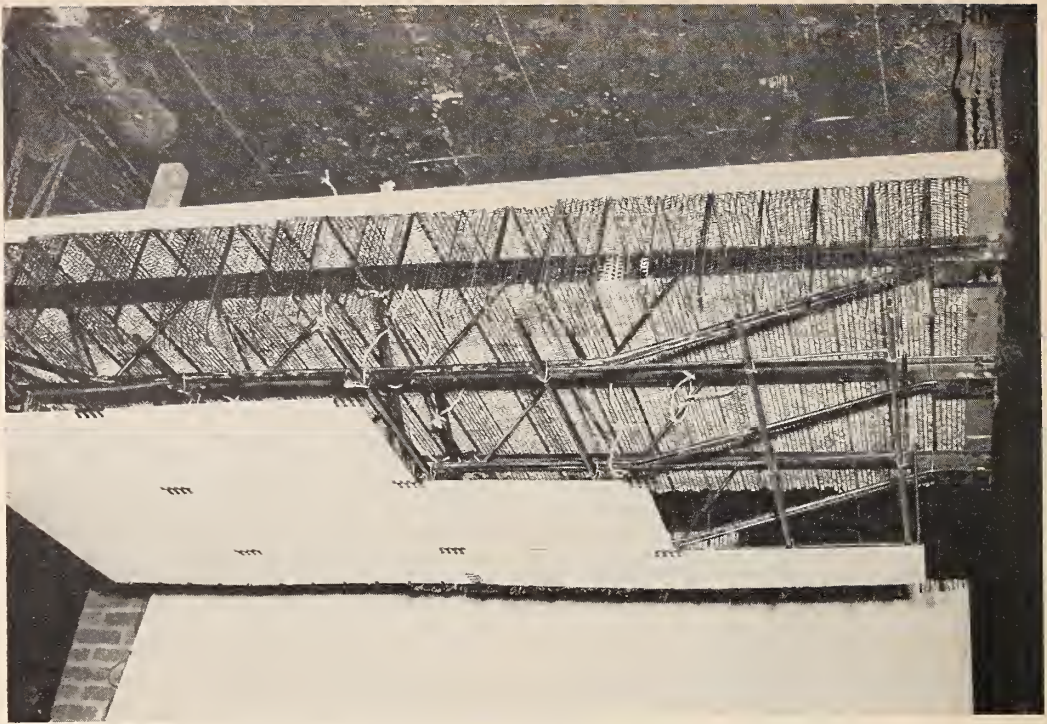
FIGURE 1. Specimen for exploratory test during construction, showing joists and slab, furring, lathing, and clips.

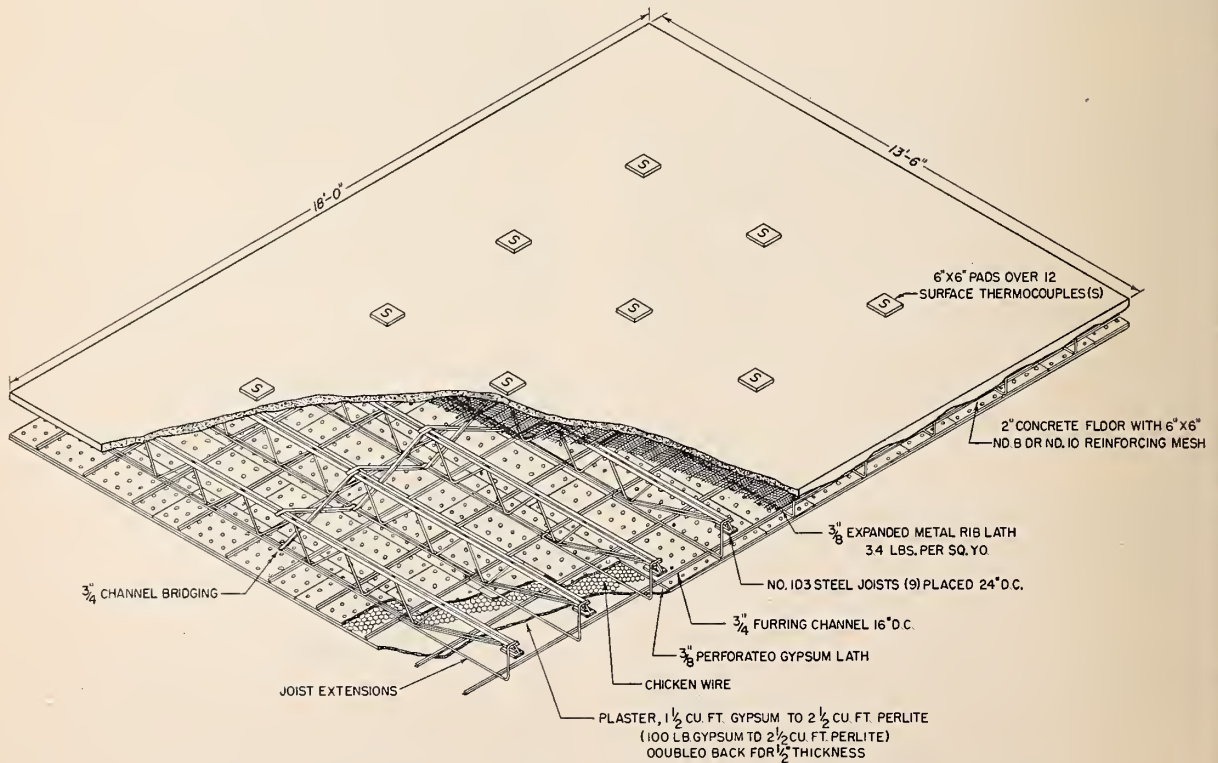
FIGURE 2. Construction details of specimen for test 312 with hexagonal-mesh wire reinforcing.

Test 312. Plaster $\frac{1}{2}$ in. on $\frac{3}{8}$ -in. lath. At 13 min, first crack; 27 min, short cracks outlined laths over part of ceiling; 1 hr, maximum crack width $\frac{1}{16}$ in., length 3 ft, 1 hr 45 min, several parallel transverse bulges or sags of small depth, probably between lines of support for wire mesh; 2 hr 43 min, small edge cracks in floor slab, little change in ceiling; 3 hr, maximum crack width $\frac{1}{8}$ in., length 6 ft; 4 hr, ceiling had developed 1 to 2 in. general sag; 5 hr, general sag of ceiling had developed into curve of 9-in. depth at center; 5 hr 20 min, local sag of $\frac{1}{2}$ in. over area 3 ft in diameter; 6 hr 15 min, ceiling fell from 4-ft² area near center; 6 hr 27 min, load off; 6 hr 34 min, gas off, more ceiling down.

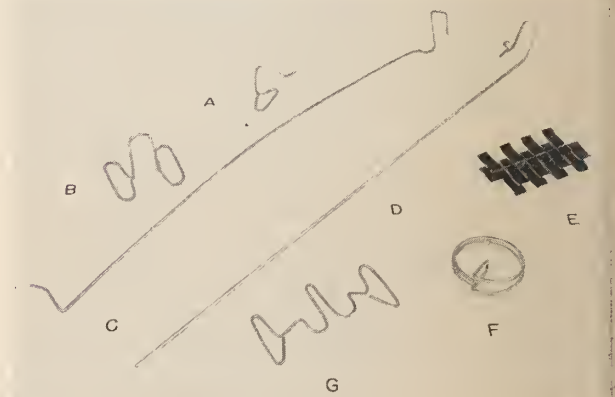
FIGURE 3. Various clips used in applying ceiling laths for the test specimens.

The gypsum lath was placed with the long dimension at right angles to the furring channels and was attached thereto by clips of one of the types illustrated in figure 3. Two of the types, C and D, provided continuous support across the width of the lath, hooking over the furring channel at one edge and joining with the adjacent clip at the other edge. A third type of clip, B, provided support only at the lath edges but was used with type A, which punctured the lath to hook over the furring at intermediate points. This combination was used in tests 316, 317, and 319 only. Still other clips (E, F, G) were used at the ends and edges of each piece of lath to keep it in alinement with the adjoining ones. These latter clips, some or all types of which were used in each ceiling, did not transmit any support from the furring channels to the lath. The lath was cut, where necessary, to carry the ceiling to the

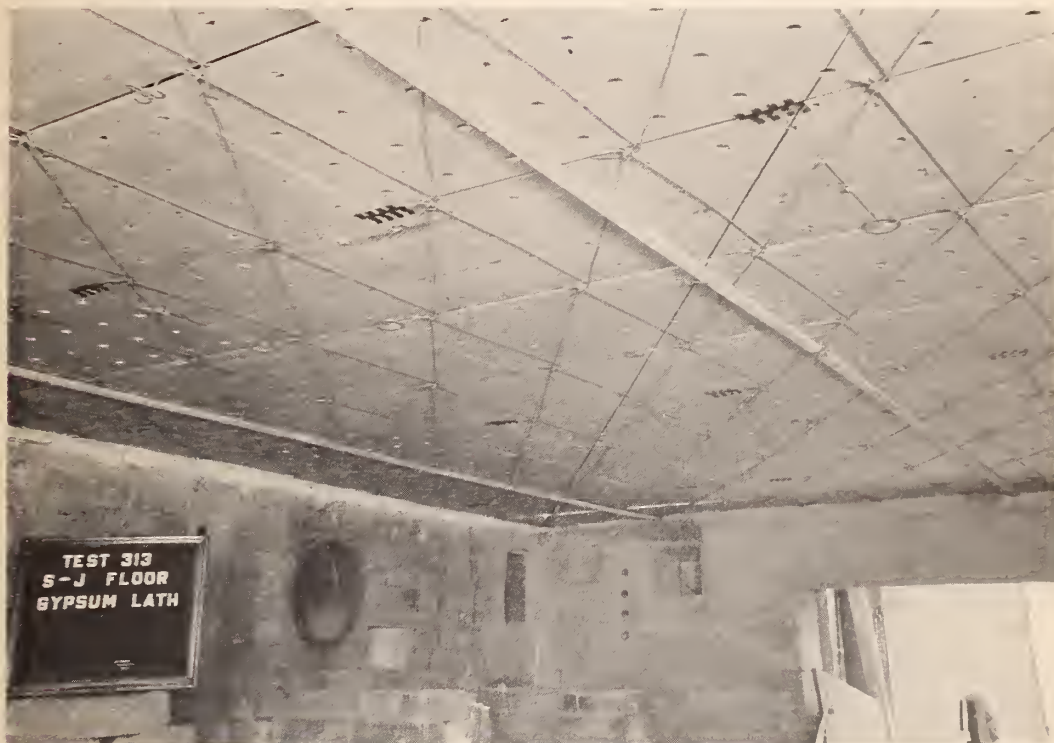
FIGURE 4. *Lathed ceiling with diagonal wire reinforcing.*

Figure 4 shows the diagonal wire support in place below the lath during the construction of test floor 313.

Test 313. Diagonal wires 10 in. apart, plaster ¾ in. on ¾-in. lath. At 13 min, first cracks along each side;

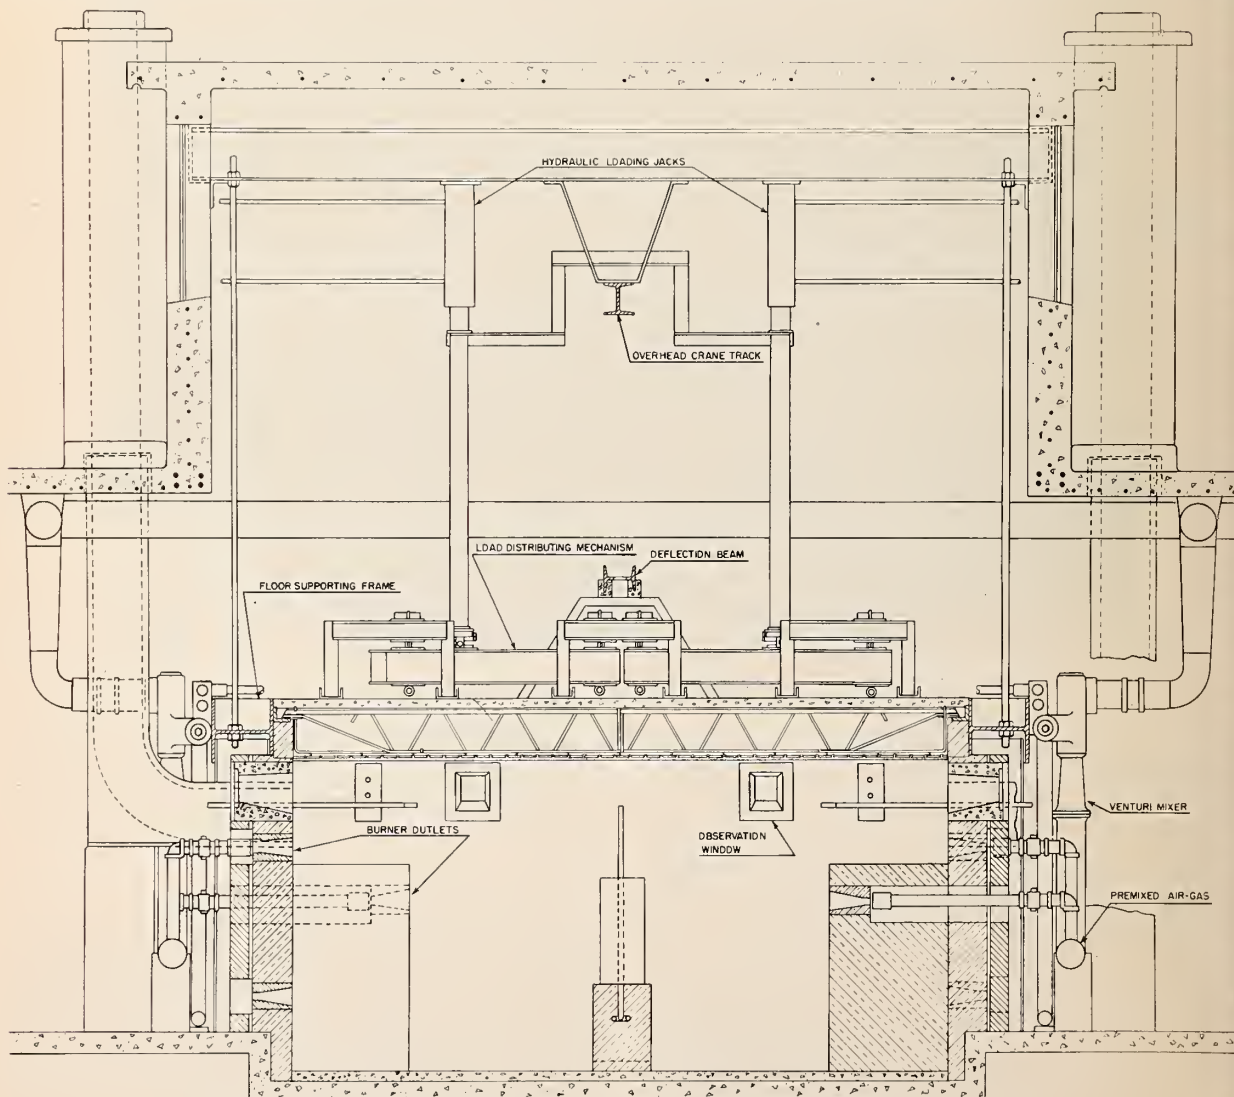
FIGURE 5. Section of the large floor-test furnace at the National Bureau of Standards.

9 ft by 4 ft 4 in., and the other tests were made in a large furnace, which took a floor 18 ft by 13 ft 6 in. The latter is shown in figure 5. Each furnace was in the form of a box open at the top, with gas burners along the sides. The test floor closed the open top, and the underside of the specimen was exposed to the furnace flames.

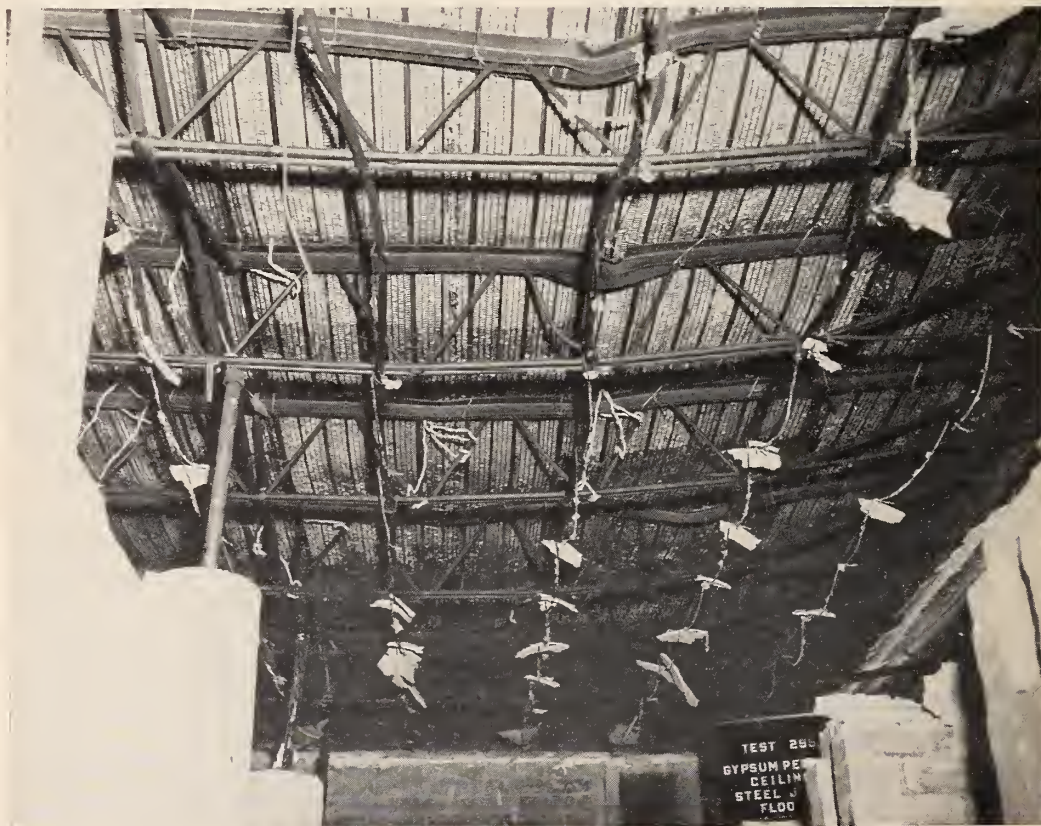
FIGURE 6. Condition of joists after test 295 of specimen with unreinforced ceiling showing buckled joists.

Test 295. Ceiling of 1 in. of plaster on $\frac{3}{8}$ -in. lath, same slab and joists as in test 287. At 2 min, white-coat plaster peeling from over half ceiling; 18 min, spot about 6-in.-diameter sagging; 27 min, half of above spot fell, another sagging 1 in.; 34 min, cracks along lines of lath joints over most of ceiling; 48 min, slight sag along crack; 1 hr 3 min, several cracks $\frac{1}{2}$ in. wide, others less; 1 hr 26 min, offset of $\frac{1}{4}$ in. along crack; 1 hr 36 min, sag of 2 in. at lath corner; 1 hr 36½ min, about 5 ft² of ceiling fell; 1 hr 43 min, load removed, floor continued to deflect under deadweight, about one third of ceiling down; 1 hr 49 min, nearly all ceiling down, joists buckling; 1 hr 53 min, gas off.

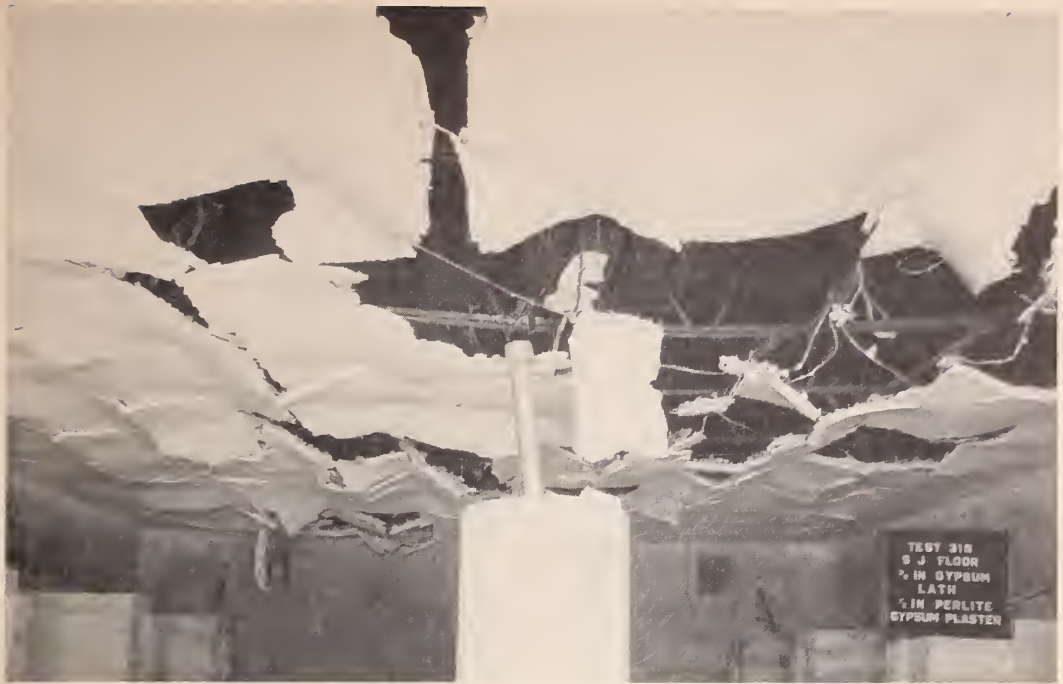
FIGURE 7. *Condition of ceiling after test 318 of specimen with diagonal wire reinforcing.*
 One or two smoothly bent joists may be seen through the opening in the ceiling.

Test 318. Diagonal wires 11.3 in. apart, plaster ½ in. on ¾-in. lath. At 8 min, first crack; 15 min, smoke from single crack; 19 min, cracks partially outlined laths; 24 min, slight sagging along two cracks; 31 min, offset of ¼ in., some peeling of white coat; 35 min, entire ceiling surface had wavy appearance; 50 min, wavy appearance lessening except for 3-in. sag along two cracks; 1 hr 15 min, corner of lath and plaster sagging 1¾ in.; 1 hr 35 min, maximum crack width 1½ in., local sag as much as 4 in.; 2 hr 6 min, many cracks ½ to 2 in. wide, corners of lath and plaster hanging down 3 to 8 in., leaving openings about 6 and 10 in. square; 2 hr 27 min, about 2½ ft² of ceiling fell; 2 hr 47 min, load off; 2 hr 53 min, gas off.

Less than one-quarter of the ceiling fell during the test and subsequent cooling. Most of the joists were bent, a few buckled slightly, and the floor slab showed no appreciable cracking.

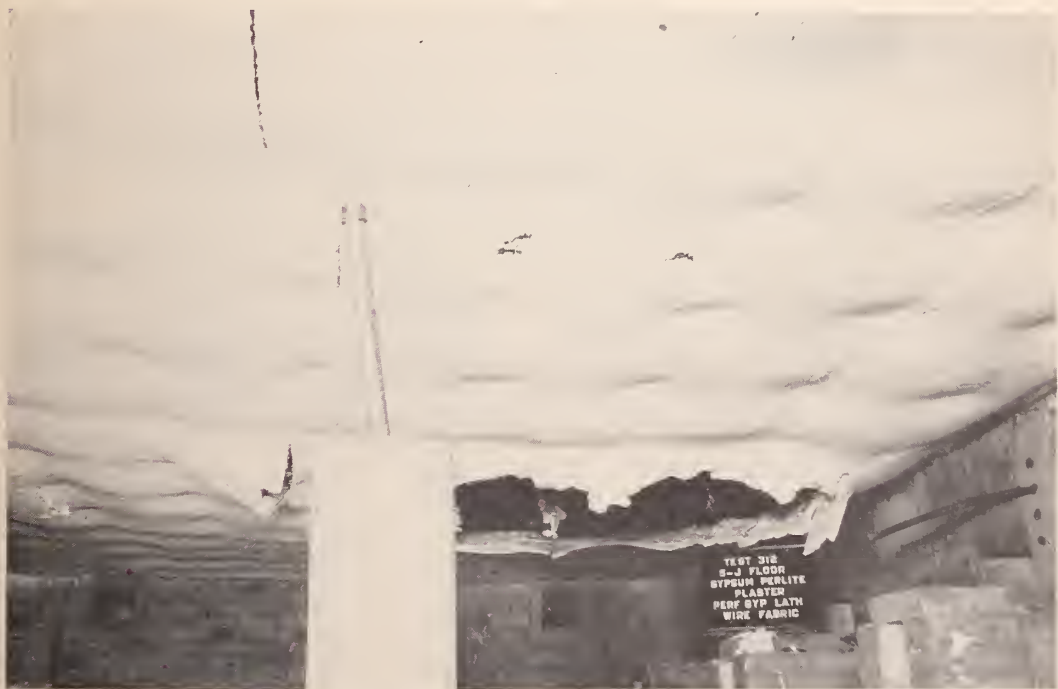
FIGURE 8. *Condition of ceiling in test 312, having hexagonal-mesh wire fabric, after 6½-hour exposure.*

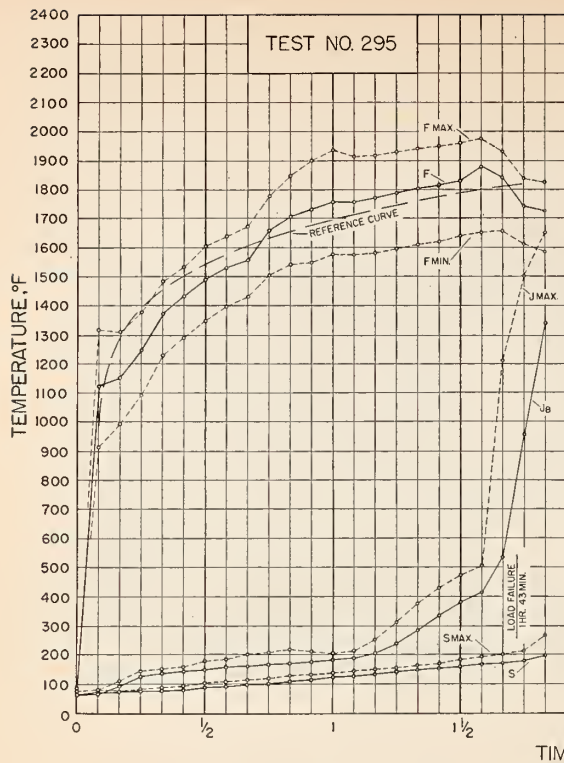
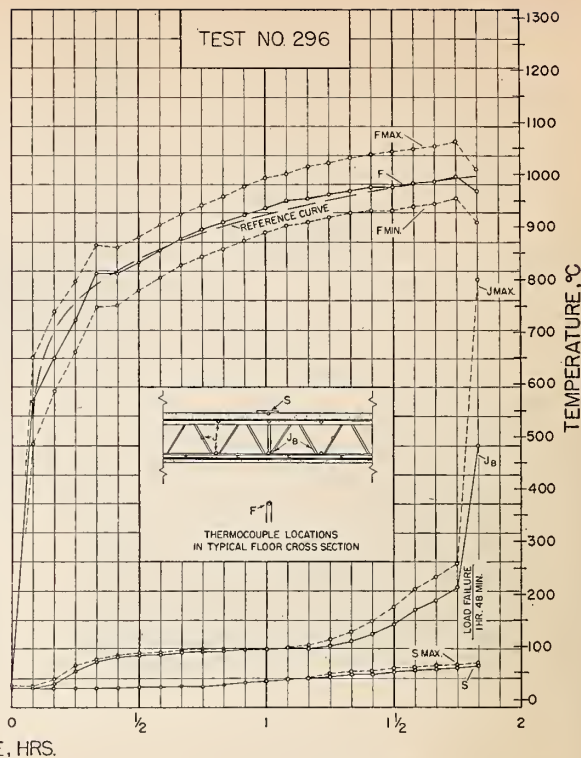
FIGURE 9. Time-temperature curves from tests 295 and 296, unreinforced ceilings.

Sketch indicates thermocouple locations. Curves labeled as follows: Standard exposure curve of E119, Reference curve; furnace temperatures, average, maximum, and minimum, F , F_{max} , F_{min} , respectively; average of bottom chords of joists, J_B ; maximum on joists, J_{max} ; unexposed surface, average and maximum, S and S_{max} .

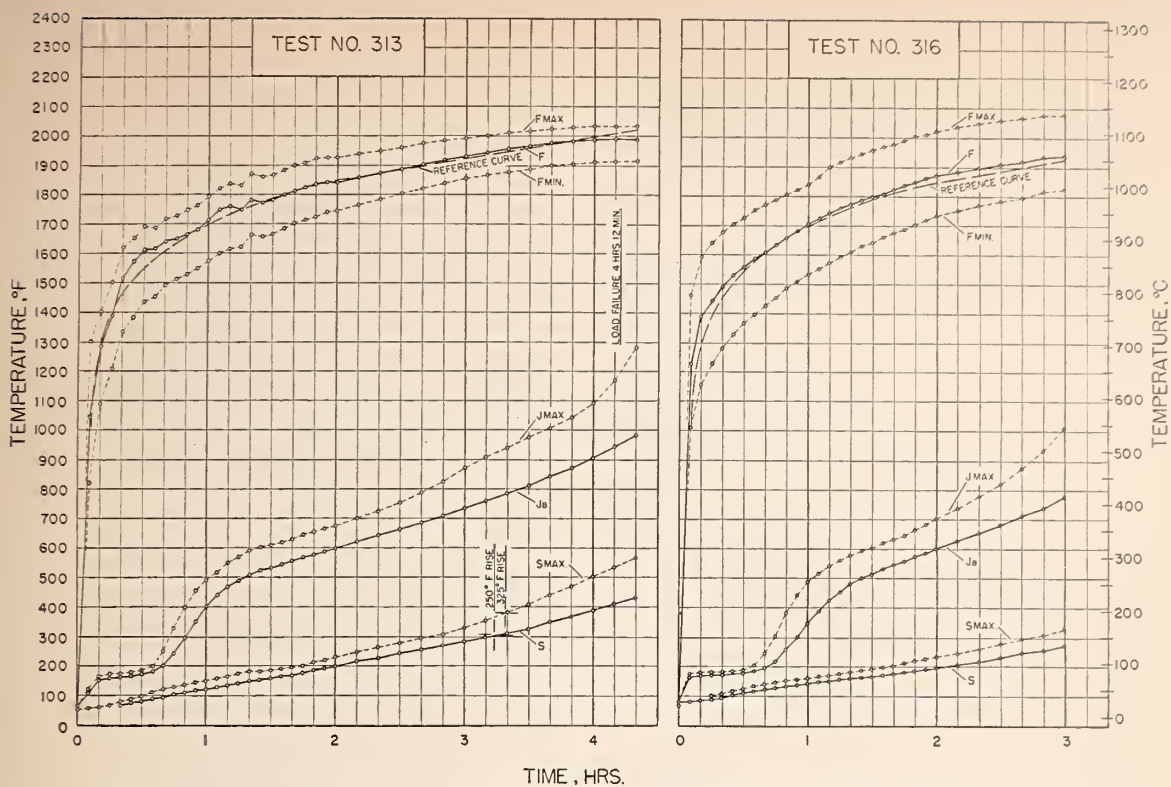
FIGURE 10. Time-temperature curves from tests 313 and 316, the former having a ceiling with diagonal wires and the latter one with extra clips.

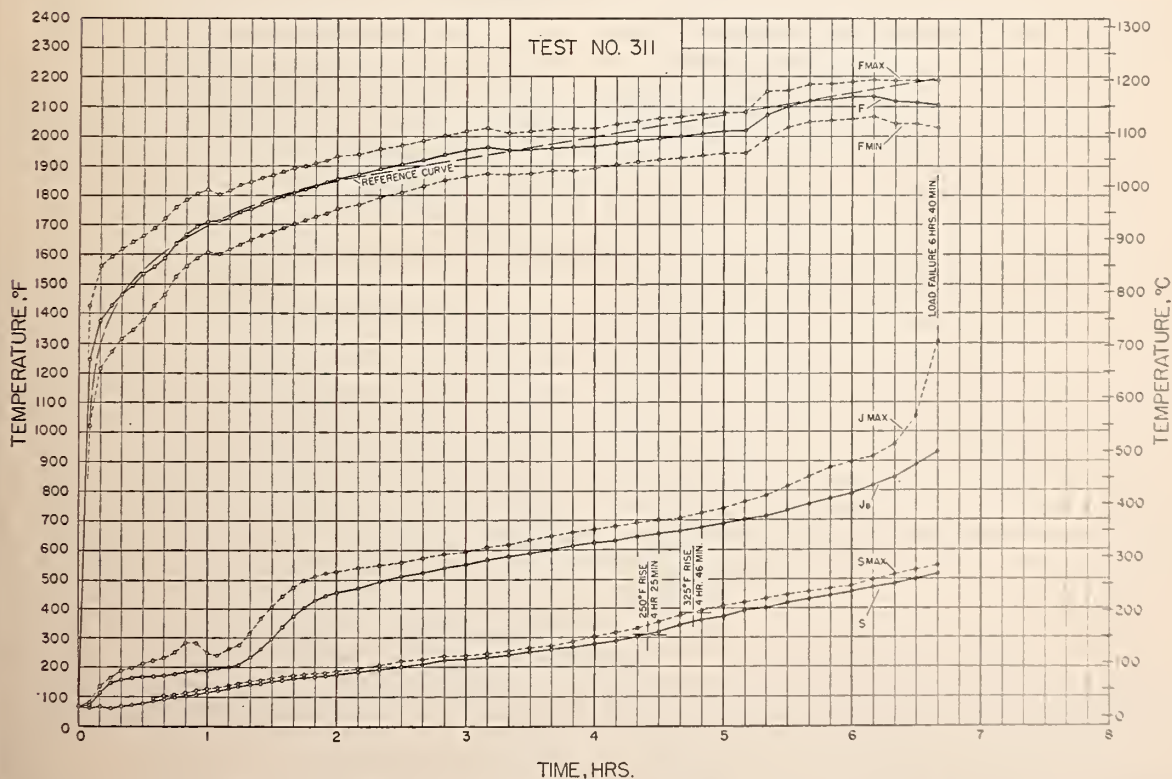
FIGURE 11. Time-temperature curves from test 311 having a ceiling with 1-in. hexagonal-mesh wire-fabric reinforcing.

Test 311. Plaster 1 in. on ¾-in. lath. At 15 min, first crack; 19 min, small blister in white coat popped; 41 min, thin smoke from crack, maximum crack width ¼ in.; 1 hr 29 min, slight sag at junction of cracks in center of ceiling, cracks nearly full length and full width; 1 hr 32 min, flames into furnace from center; 1 hr 42 min, offset of ½ in. at center, cracks not over ¾ in. wide; 4 hr, no noticeable change in cracks, sag, or offset since about 1¼ to 2 hr; 4 hr 50 min, sag at center about ¾ in.; 5 hr 40 min, local sag at center 1½ in., widest crack ½ to 1 in.; 6 hr, the whole ceiling had settled slowly into a curve whose depth at the center was about 1 ft, local offset of 2 in., local sag about same; 6 hr 25 min, oily burlap bag that had been on top of floor ignited, some cracks 1 in. wide, others offset up to 6 in.; 6 hr 34 min, opening 6 to 8 in. wide due to sag

At the end of the test no plaster had fallen, but it was thoroughly cracked. The joists were bent but not buckled. No appreciable amount of plaster fell after the test.
